INVESTIGATION OF FRAGMENTS FROM SPACE VEHICLES

Gilbert Larsson

Translation of "Undersokning av Fragment fran Rymdfarkoster"
Forsvarets Forskningsanstalt, Avdelning, Sundbyberg
(Sweden), Report FOA-1; A-1433-40(12), April, 1968,
43 pages

ABSTRACT. In the present report an account is presented of an investigation of two found objects of foreign origin. The purpose was to determine their nature, origin and use, and to try to develop a certain routine for investigations of this kind. The result of the investigation shows that one object has been identified with a high degree of probability as a component of space vehicle 1965-26A. The second object might be derived from one of six indicated space vehicles from 1964. In both cases the origin is American.

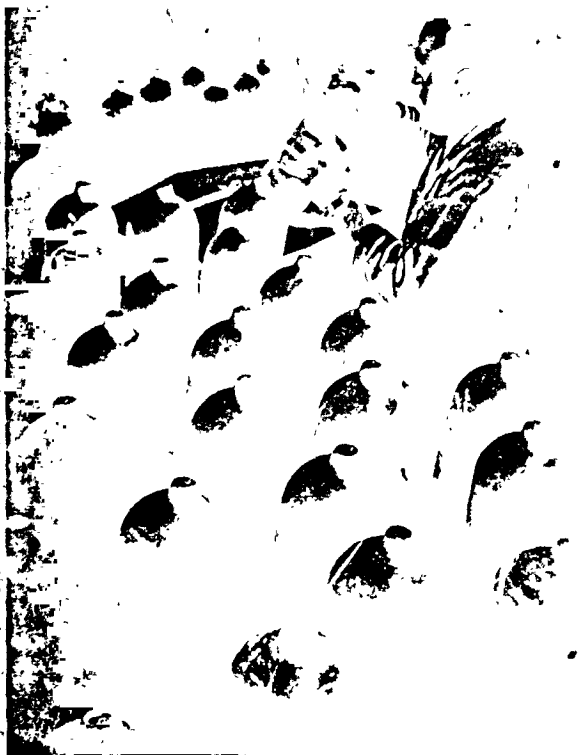
Figure 13—Cylindrical forgings of the beta titanium grade at receiving inspection. Sections will be machined and two welded together to provide completed air reservoir bottles, each 3½ pounds.
